HOUSATONIC RIVER FLOOD CONTROL

EAST BRANCH DAM & RESERVOIR

DESIGN MEMORANDUM NO.2

SITE GEOLOGY

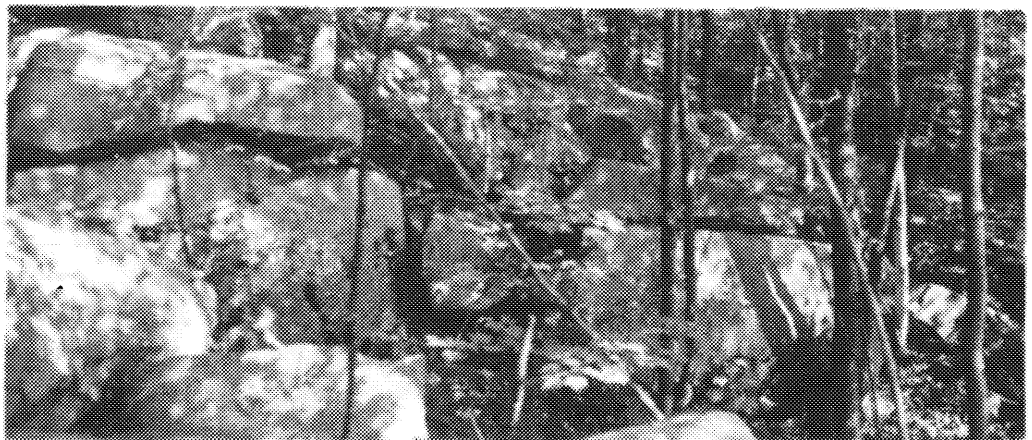
TYPICAL BEDROCK EXPOSURES

RIGHT ABUTMENT

LEFT ABUTMENT

10. Bedrock is exposed over a wide area on the upper right abutment, and to a limited extent in the river and on the left abutment. The actual amount of exposed bedrock may vary considerably from that indicated on the Plan of Foundation Explorations, Plate No. 2-2 since small outcrops are not always distinguishable from the large boulders and blocks which litter the ground surface in many places. The bedrock consists principally of granite gneiss with included
